# DREWRY HOME INSPECTIONS, INC.

## PROPERTY INSPECTION REPORT

1234 Main Street, Fairfax, VA 22033

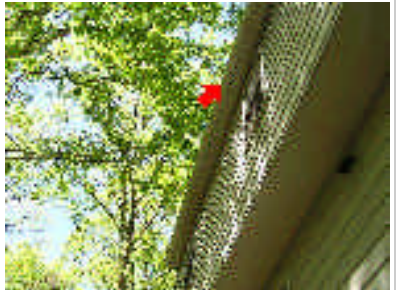
GUTTER TYPE & CONDITION:	<p><b>TYPE:</b> Aluminum, <b>CONDITION:</b> DEFECT. Gutters, gutter screens and possibly downspouts, need cleaning to restore proper operation.</p>

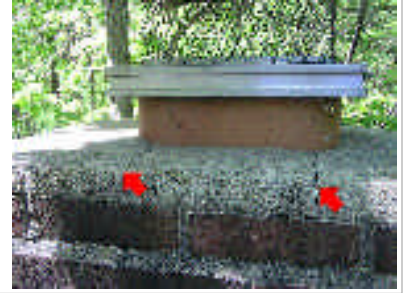
CHIMNEY CONDITION 1:

**DEFECT.** The chimney mortar crown is cracked. Crown needs cracks patched to prevent water penetration.

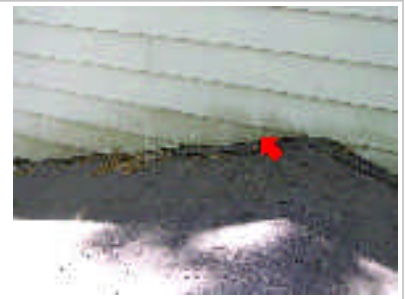
WALL COVERING/SIDING  
CONDITION 1:

Metal Siding has miscellaneous minor defects and stains which are common with this material at this age. Budget to replace the siding at sometime in the future.

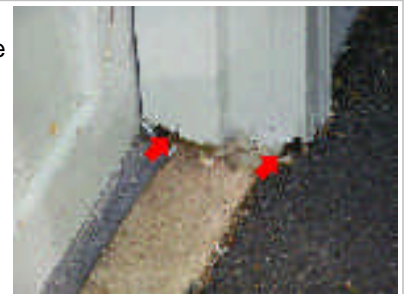
EAVES & TRIM CONDITION  
1:

**DEFECT.** Some exterior wood trim has water damage/rot and needs repairs or replacement at the garage overhead doors.

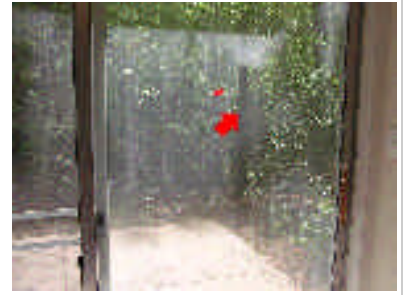
## EXTERIOR DOOR CONDITION 1:

**DEFECT.** Basement patio door glass is fogged and both doors exhibit signs of deterioration as a result of age and general wear. Doors need repairs or replacement.

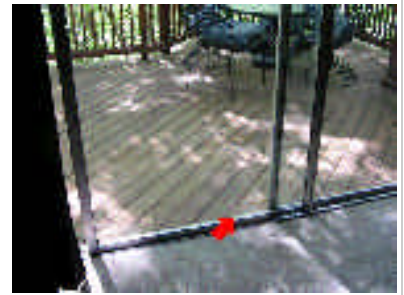
## EXTERIOR DOOR CONDITION 2:

**DEFECT.** Upper patio door screen is missing and door is very difficult to open and close due to worn out rollers.

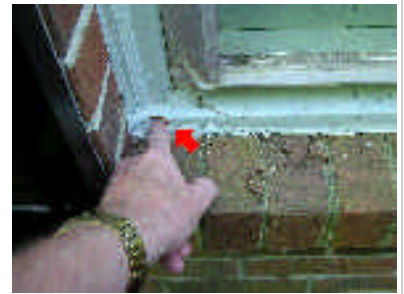
## WINDOW EXTERIORS CONDITION 1:

**DEFECT.** Some water damage and rot at some windows at exterior. Repair as required.

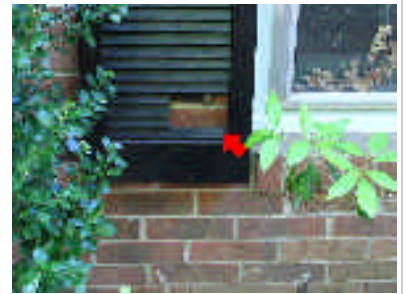
## SHUTTERS:

**DEFECT.** Damaged/deteriorated window shutters present--Need repair/replacement.

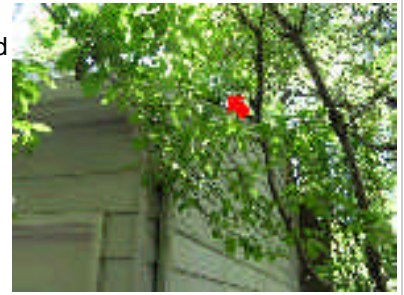
TREES & SHRUBS

**DEFECT.** Trees and shrubs are too close or in contact with the house and roof. Cut back trees and shrubs as required.

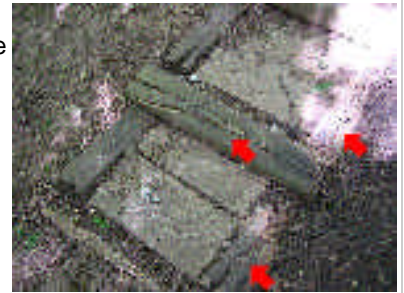
WALKS:

**Type-** Brick, Wood.& Flagstone . **CONDITIONS:**  
**DEFECT.** Wood steps at flagstone walk at right side of house has rot and needs repairs for safety.

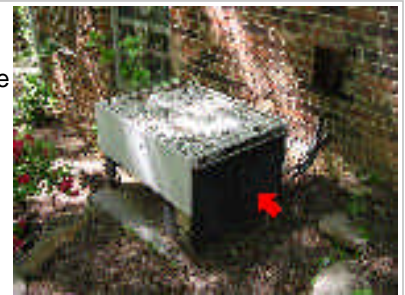
AIR CONDITIONING PRESENT?:	Yes.
LOCATION:	Side exterior.
TYPE/CONDITION:	Central, Split-System.
POWER SOURCE:	220 Volt.
OUTDOOR UNIT AGE IN YEARS:	A/C #1 is beyond its average life expectancy-- <b>Budget For Replacement.</b> The average life expectancy for an A/C unit is 10 to 15 years; the age of this unit is:24.

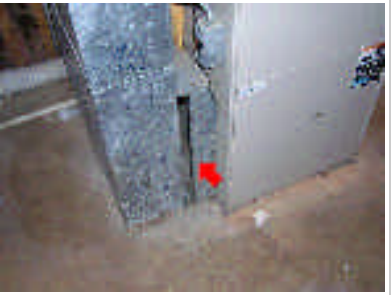
MANUFACTURER:	Tappen.
INPUT AIR TEMPERATURE:	75.
OUTPUT AIR TEMPERATURE:	50.
TEMPERATURE DIFFERENTIAL:	24.
SYSTEM OPERATING CONDITION:	<p><b>DEFECT.</b> A/C #1 is producing an abnormally low temperature differential indicating defective operation. I suspect the inside coil is dirty and needs to be chemically cleaned by an HVAC company due to unit being operated without a filter installed.</p>

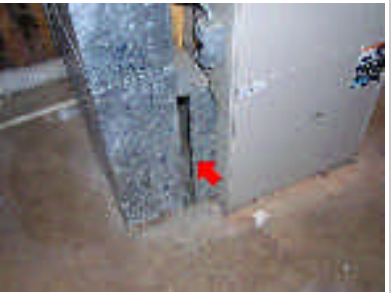
TYPE:	Sheet metal.
CONDITION:	Ducts appear satisfactory. Airflow appears to be satisfactory at accessible registers.
AIR FILTERS:	Disposable. <b>DEFECTS.</b> Missing/damaged filter present at basement. Replace filter.

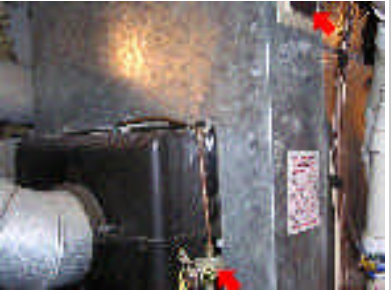
HUMIDIFIER:	Appears satisfactory.
	<p><b>DEFECT.</b> Humidifier is operating and humistate is missing parts. Unit will not shut off. Repair or replace as required.</p>

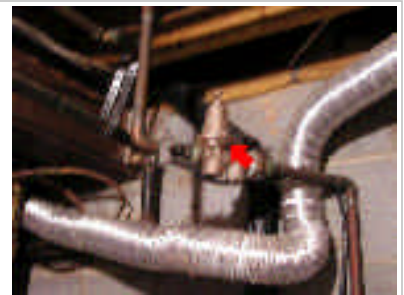
Main water shut-off valve was located and appears satisfactory. This valve was not turned or tested! **DEFECT.** Leak noted at main water pressure reduction valve in basement above dryer. Have a plumber replace the valve.

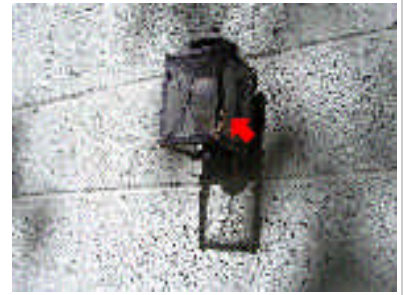
EXTERIOR LIGHT  
FIXTURES # 1:

**DEFECT.** Basement exterior light not working.

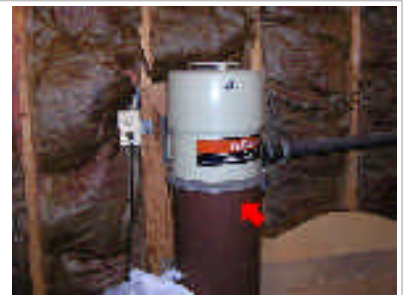
LIGHTING FIXTURES/  
SWITCHES/RECEPTACLES  
2:

**DEFECT.** Central vacuum in the basement is not working.

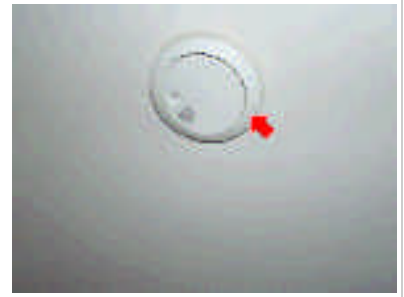
Smoke detectors are present, at every level,  
**DEFECT. Safety Concern:** The following smoke detector(s) failed to work when manually tested and need repair/replacement: 1st Floor, 2nd Floor, Basement.

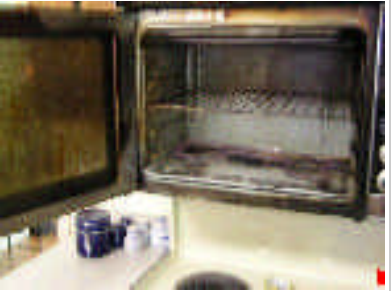
KITCHEN SINK TYPE:	Stainless Steel.
KITCHEN SINK CONDITION:	Kitchen sink appears to be in satisfactory condition.
RANGE/OVEN TYPE:	Fuel Type: Electric.
RANGE/OVEN CONDITION:	<b>DEFECT.</b> Front right burner and lower oven lower element not working. Range/oven is near/at its average life expectancy--Budget For Replacement.

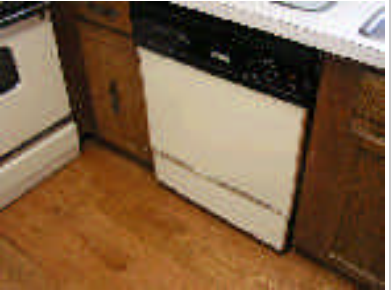
DISHWASHER CONDITION:	<b>DEFECT.</b> Dishwasher drainline needs to be cleaned. Overflows at sink airgap when dishwasher is operated. One or both of the dishwasher door counter balance springs are gone allowing door to fall with greater force--Safety Hazard. Some knobs missing at controls. Budget to replace this dishwasher.
-----------------------	--

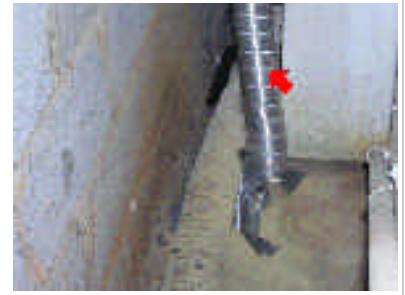
DRYER HOOK-UP  
CONDITION:

Dryer 240 volt electrical service appears to be satisfactory. **DEFECT.** The dryer vent piping is damaged/disconnected--Needs repair.

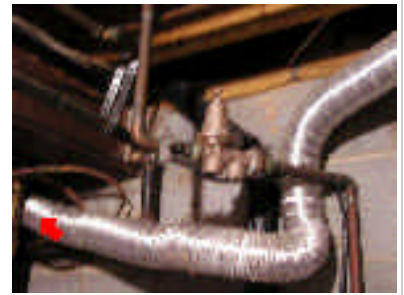
VENTILATION CONDITION  
1:

Exhaust Fan, **DEFECT**. The ventilator fan does not exhaust to the exterior of the dwelling (Improper) in the basement bath.

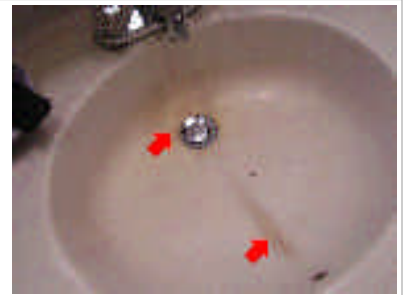
SINK CONDITION 1:

**DEFECT**. Due to the water temperature having been above 140 degrees, surface cracks have formed in the synthetic marble sink in the hall and master baths.

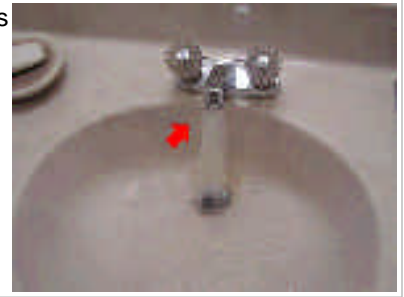
## SINK CONDITION 2:

**DEFECT.** Aerator at the sink faucet is missing parts or restricted in the powder room.

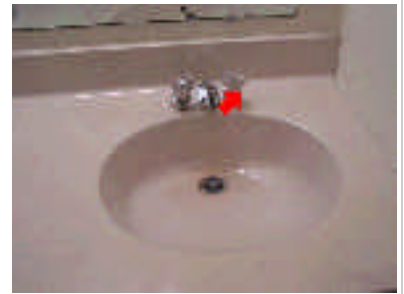
## SINK CONDITION 3:

**DEFECT.** The sink faucet not working at hall and master baths.

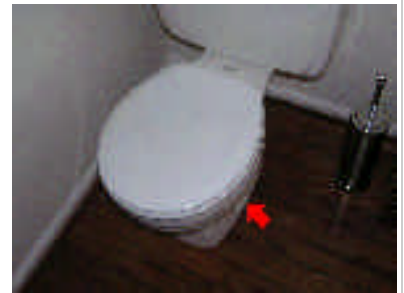
### TOILET/BIDET CONDITION 1:

**DEFECT.** The toilet is not tightly secured to the floor which can allow leakage from the wax seal in the powder room, basement, hall and master baths.

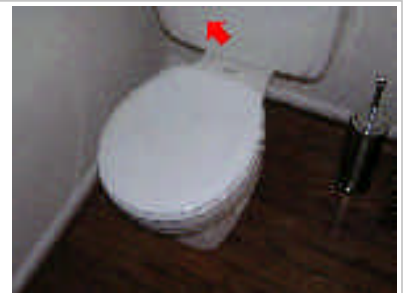
### TOILET/BIDET CONDITION 2:

**DEFECT.** Improper Flush: The flush handle has to be held down to flush toilet in the powder room and basement baths.

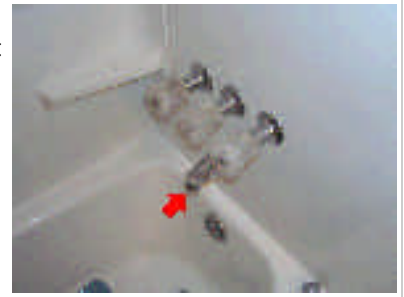
TUB CONDITION 1:

**DEFECT.** Water leakage is noted from the tub at the following areas: Leaking from base of tub faucet spout in the master bath tub.

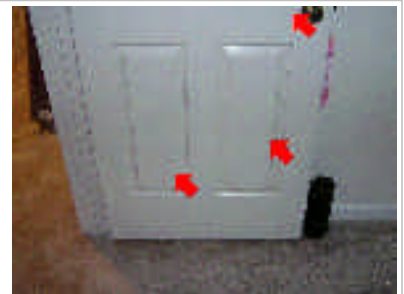
DOOR CONDITION 1:

**DEFECT.** Right rear bedroom door has damaged and poor repairs.

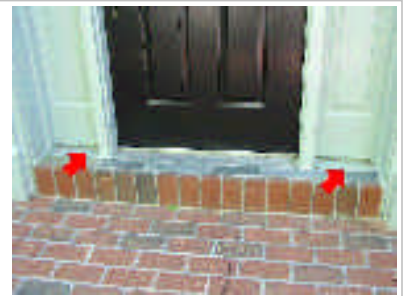
DOOR CONDITION 2:

**DEFECT.** Front door metal threshold is sloped toward the house due to settlement and needs to be caulked to prevent water from leaking into the house.

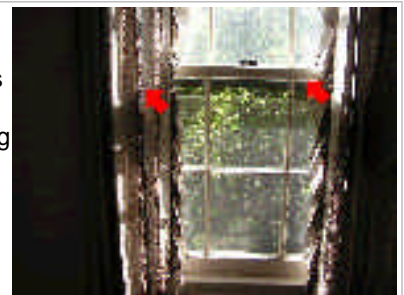
WINDOW CONDITION 1:

**DEFECT.** Damaged/broken sash cords or counter-balances present--This is a **Safety Concern**, especially in bedrooms where the windows serve as the secondary means of egress in case of fire or emergency. Window sashes can fall upon unlatching which also presents a **Safety Hazard**. Windows Need Repair.

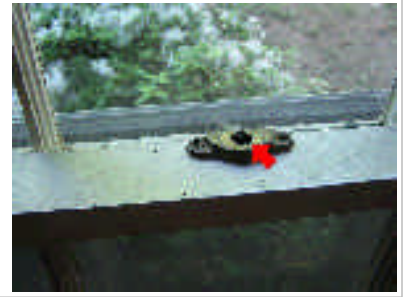
WINDOW CONDITION 2:

**DEFECT.** One living room window is missing lock.

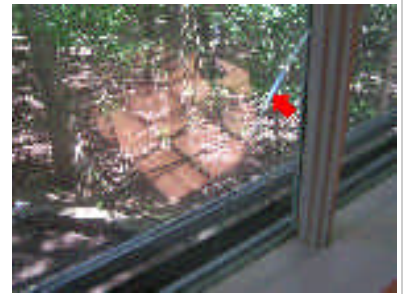
WINDOW CONDITION 3:

**DEFECT.** Broken glass at one dining room window.

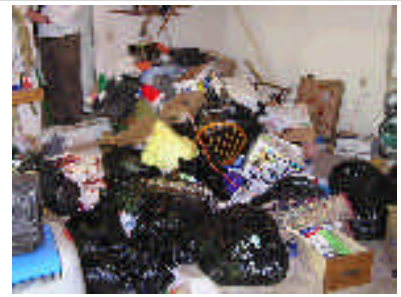
WALL/CEILING/FLOOR  
CONDITION:

**NOTE: Inspection was limited due to storage in the garage. Check on final walk through inspection.**

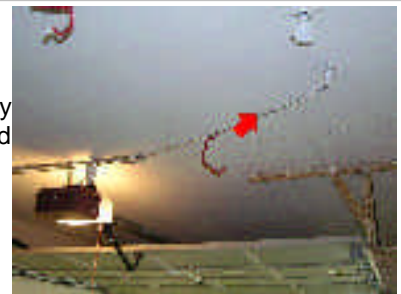
AUTOMATIC GARAGE  
DOOR OPENERS:

Automatic door opener(s)- operated as designed and appear to be satisfactory. **DEFECT.** The automatic door opener(s) have extension cord(s) installed to provide power to units. This is temporary wiring of a permanently affixed motorized device and is, therefore, not considered safe. Have a licensed electrician install an outlet with a non-switched power supply on ceiling to provide power to unit.

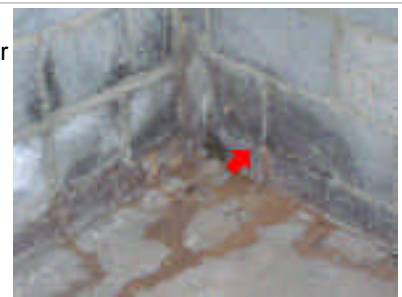
#### SIGNS OF WATER PENETRATION:

**DEFECT.** Evidence of water penetration through foundation seen at area under family room. (Former crawl space) Water stains indicate water on floor. Areas of penetration have elevated moisture levels now. Suspect the foundation drain is not to daylight or blocked at this area. Repair as required.
